Moisture Problems in Building Envelopes

Norbert Krogstad
Principal

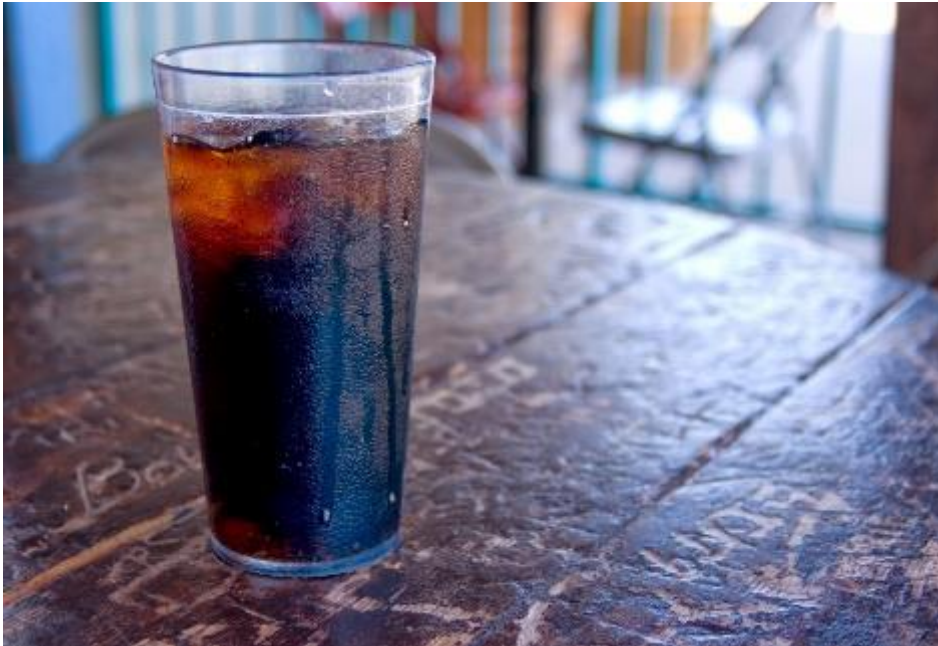
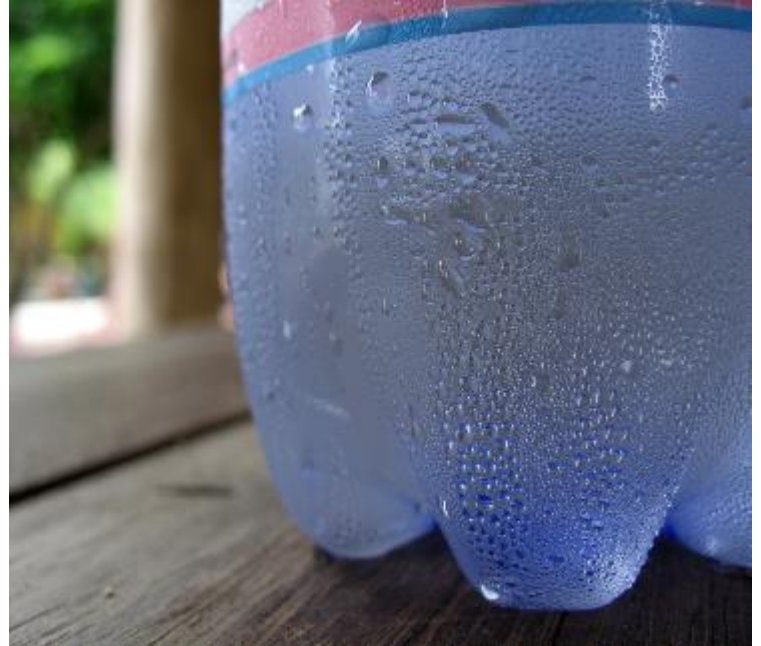
Moisture Deposition

Cold objects will cool adjacent air. If these objects are colder than the dew point temperature of this, water from the air is deposited (condensation).

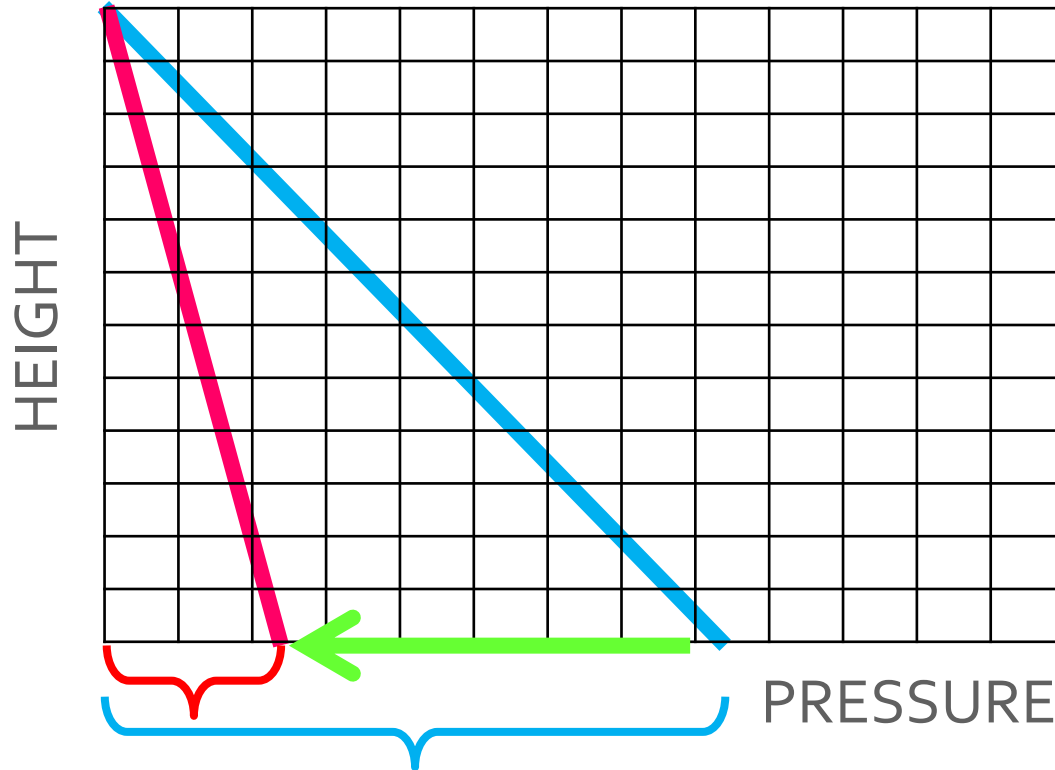
Stack Effect (Cold Weather)

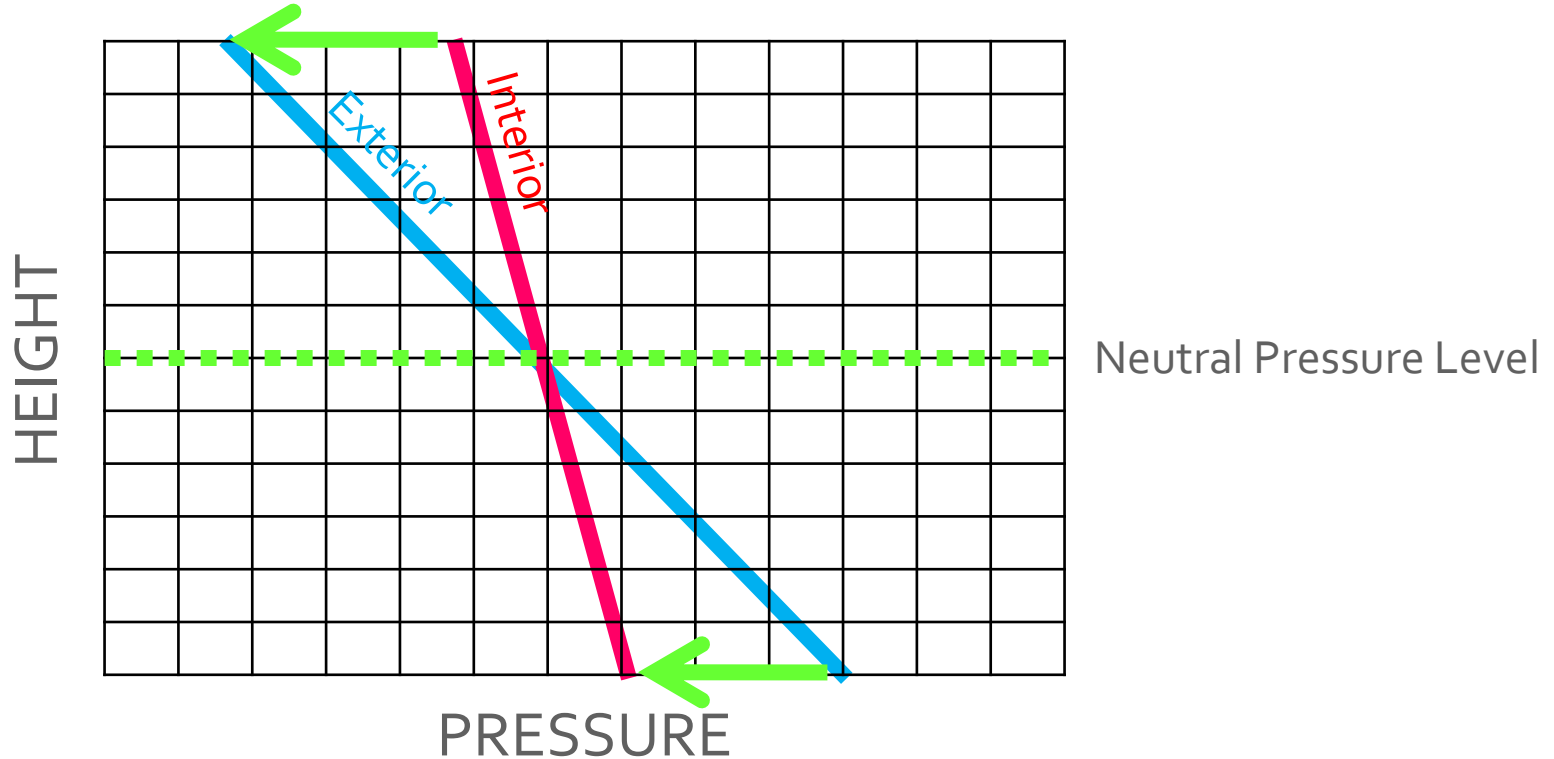
Stack Effect (Cold Weather)

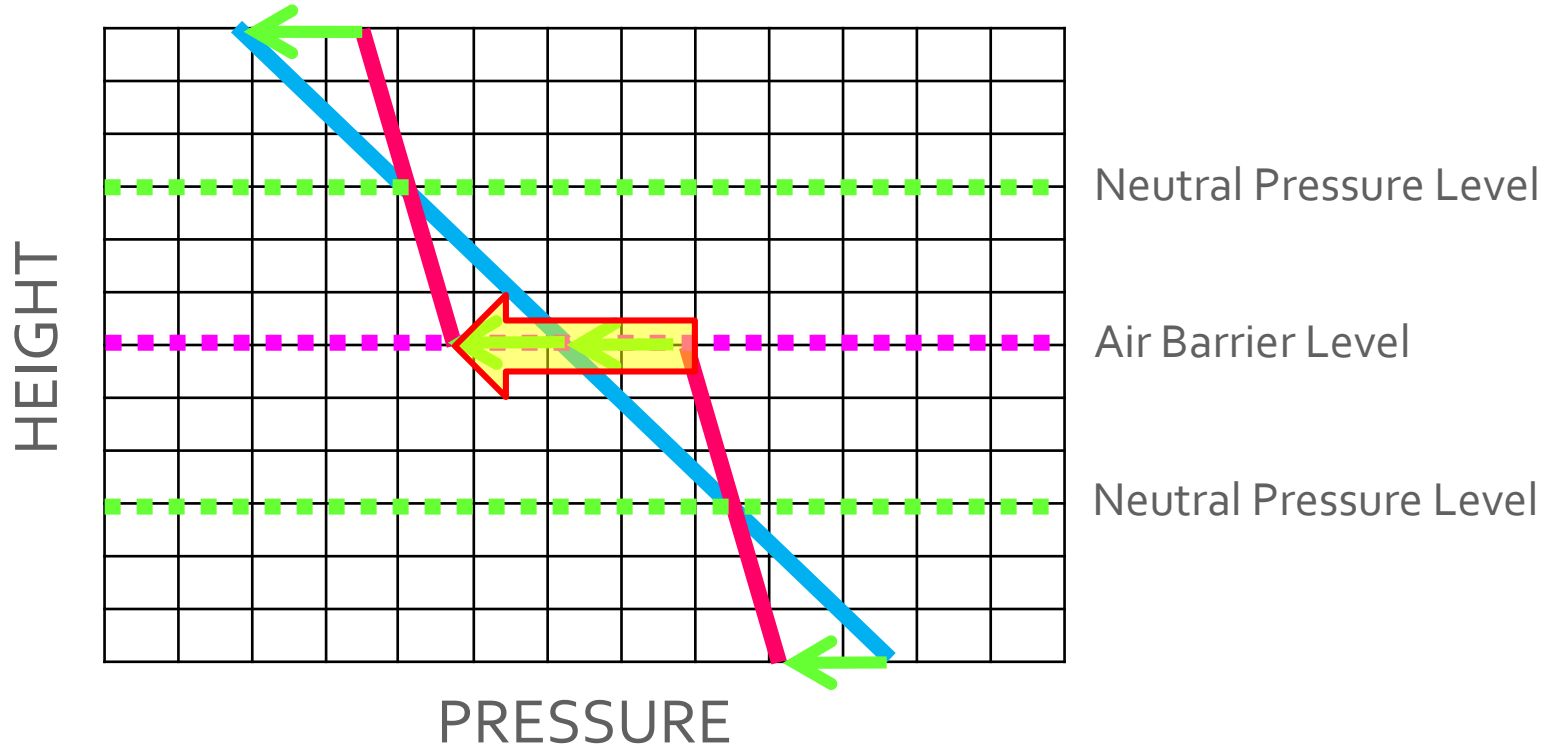
Stack Effect (Air Barrier Cold Weather)

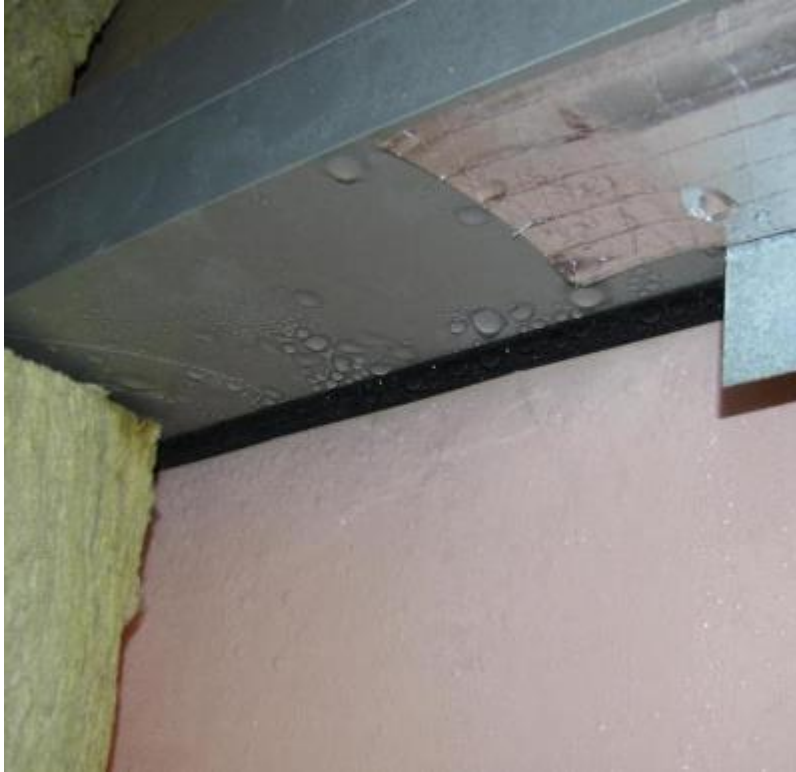
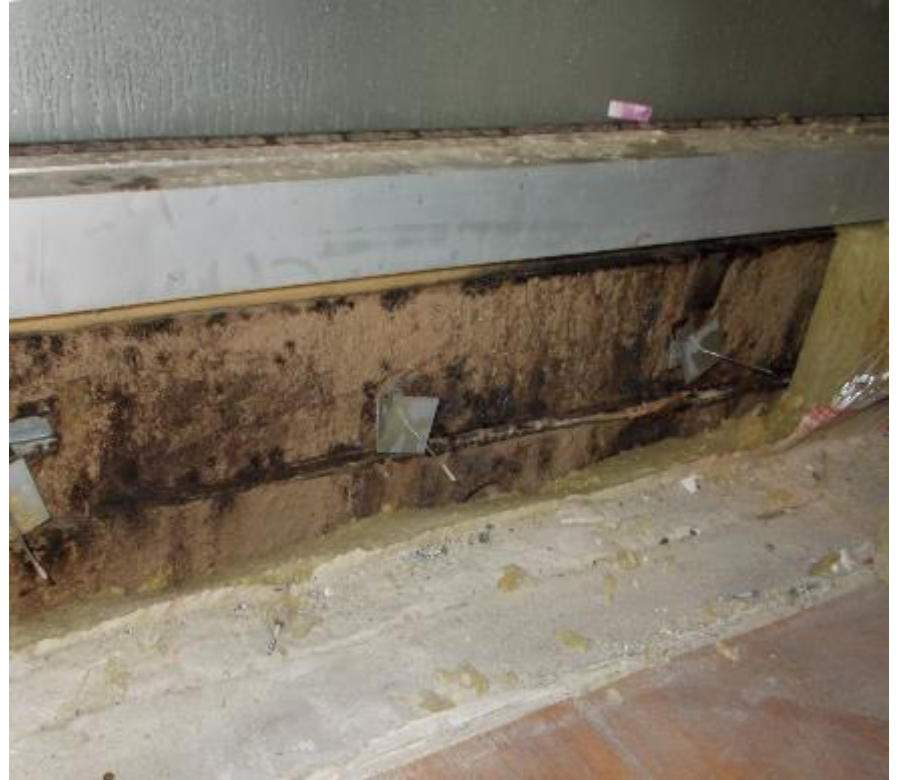
Cause (Cold Surfaces at Precast)

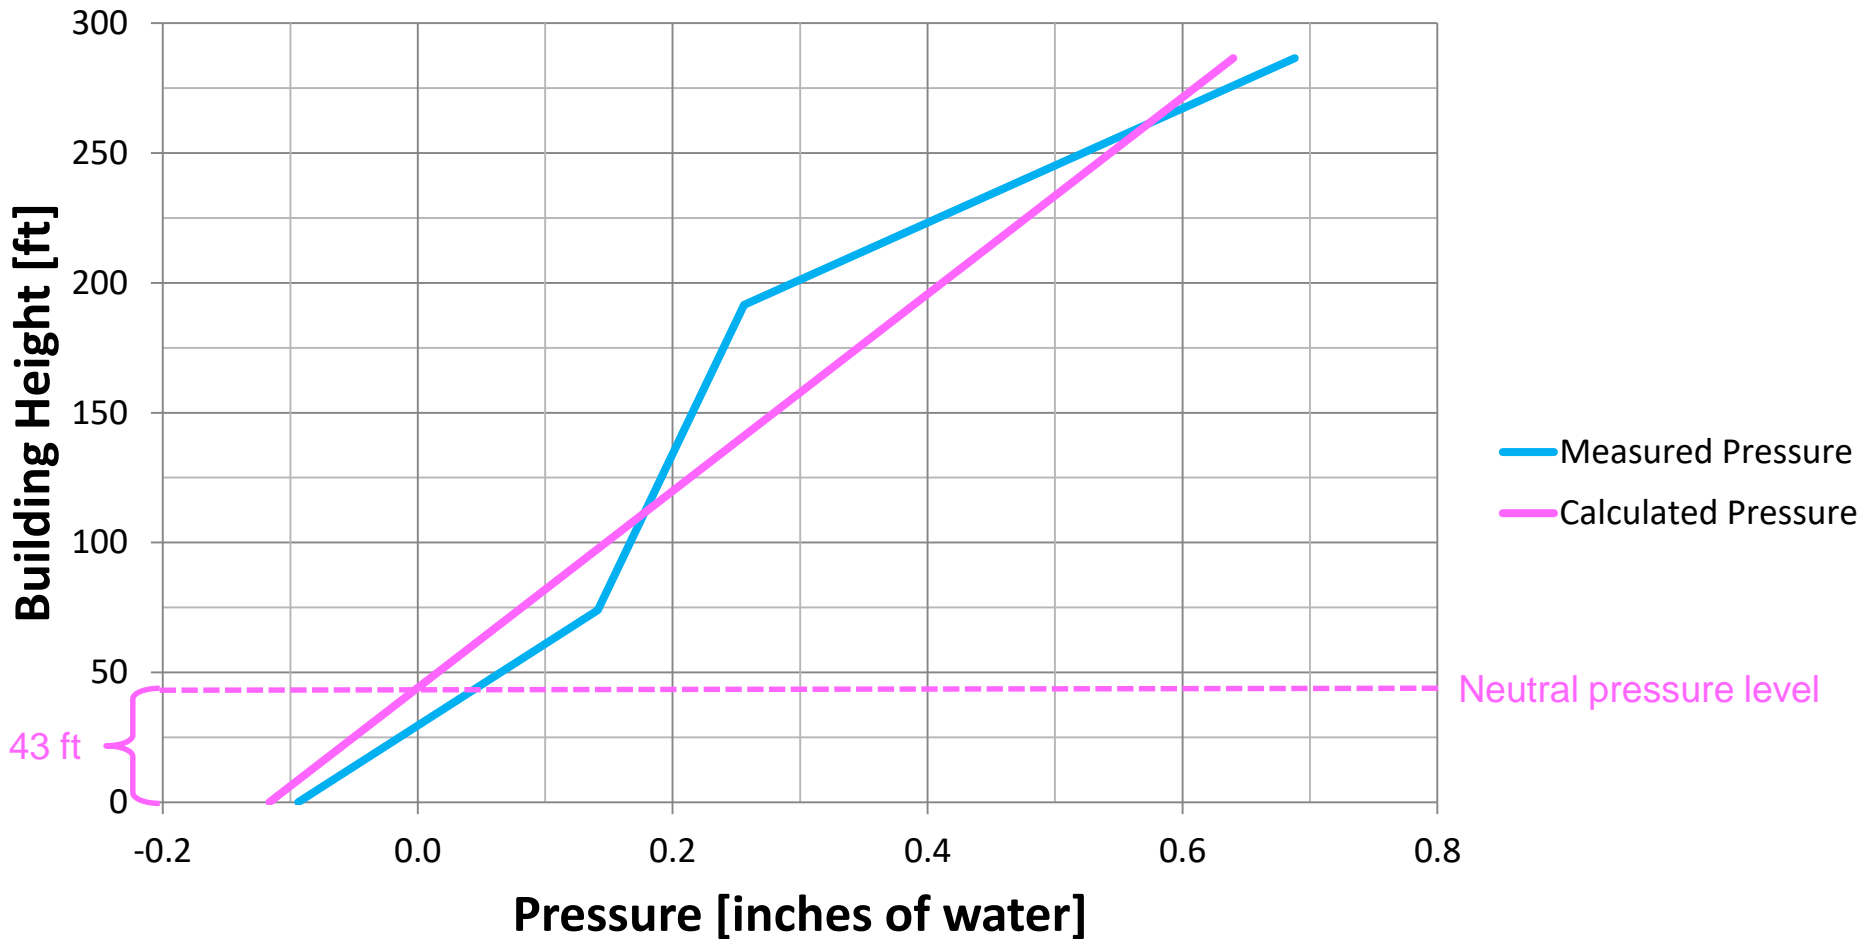
Building Pressures: -12°F Outdoor Temperature (January 6, 2014)

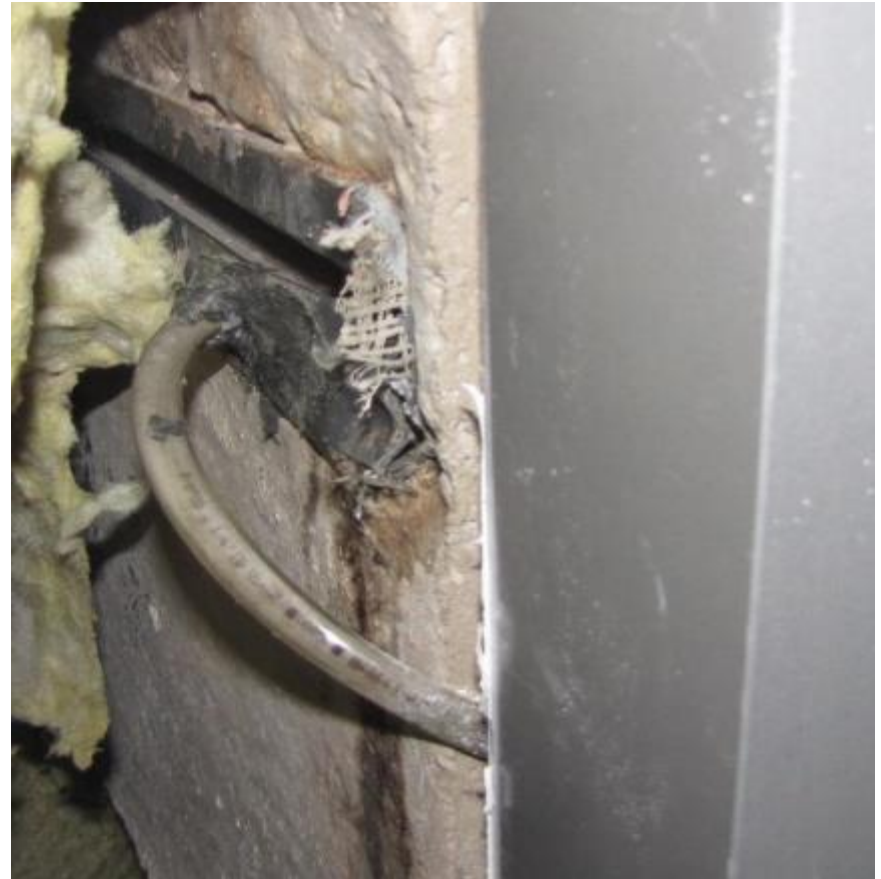
Cause (Airflow Path – Gutters)

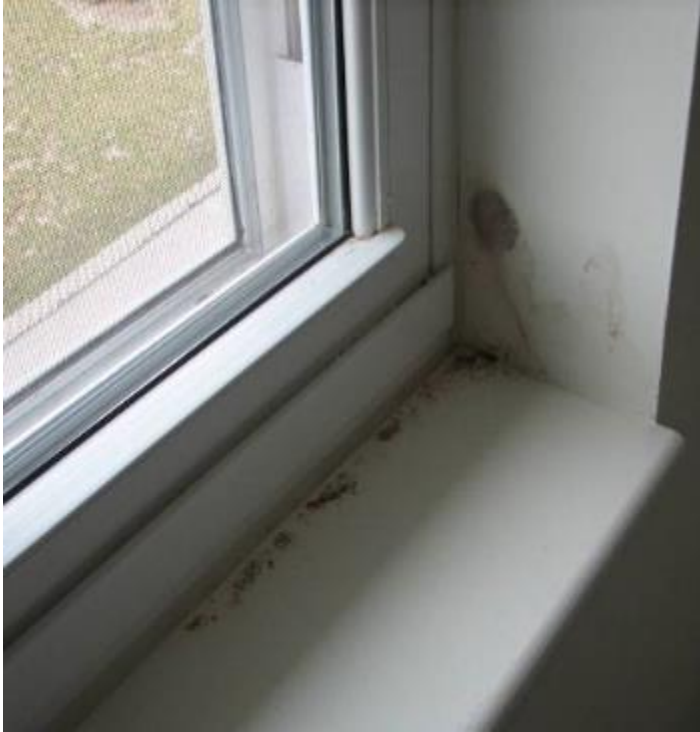
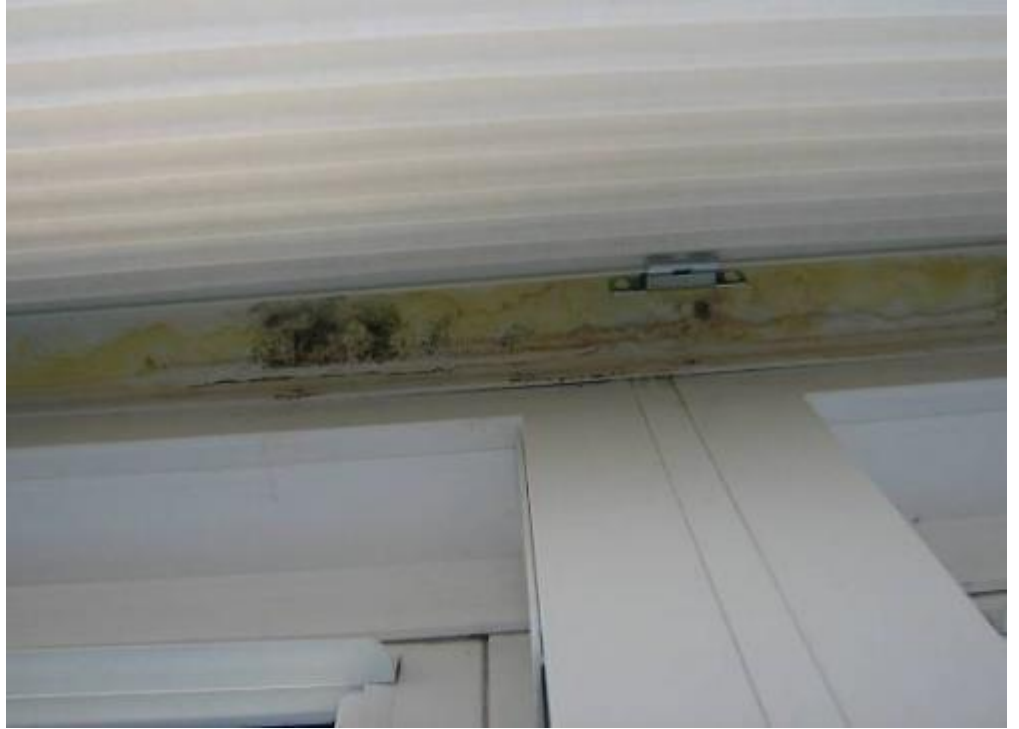
Staining and Growth at Windows

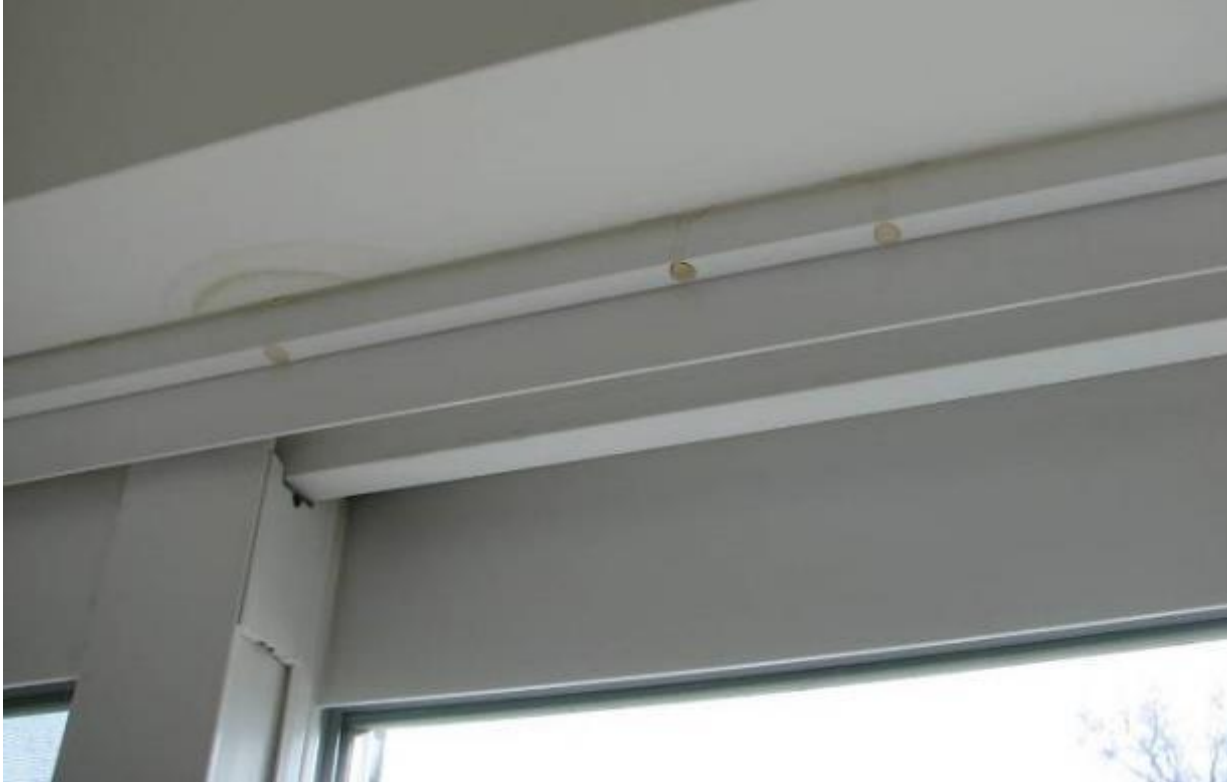
Dripping Water over Windows

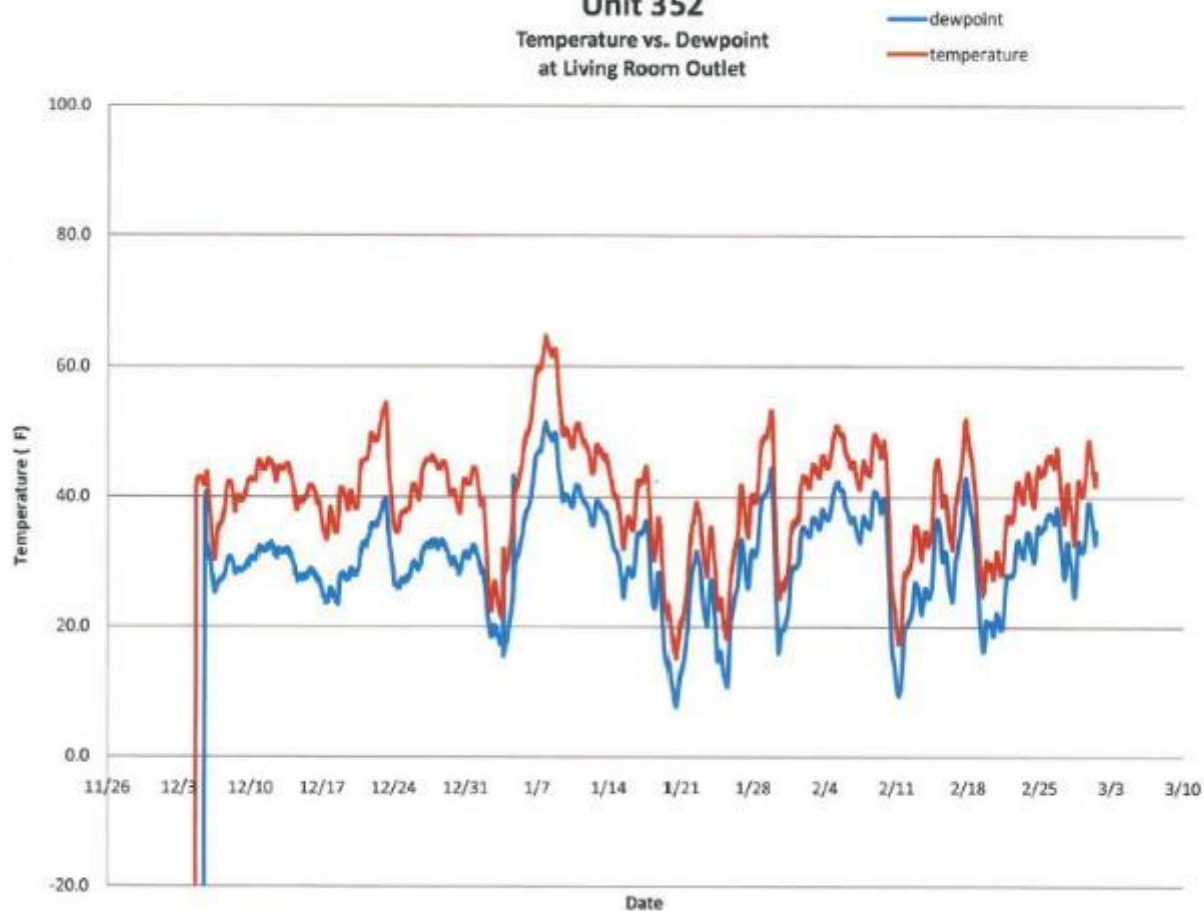
Unit 352

Temperature vs. Dewpoint
at Living Room Outlet

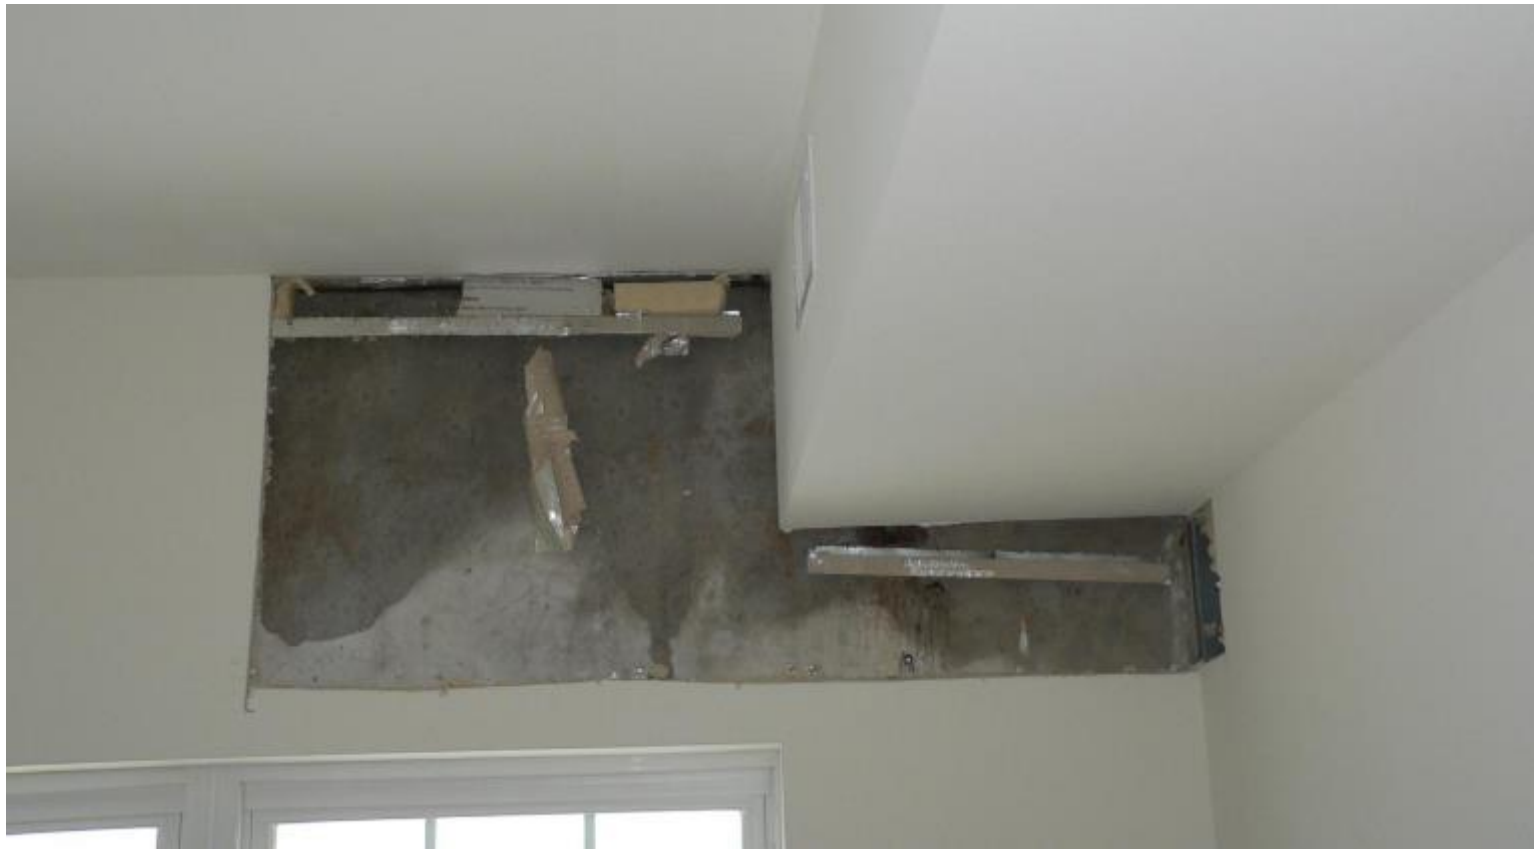
Air moves from pressurized soffit to wall

- a. Soffit containing duct with pressurized supply air was connected to the exterior walls (no barrier).
- b. Joints in ductwork are not airtight.
- c. Humidified air leaking from ductwork flowed against the interior surface of the precast concrete.

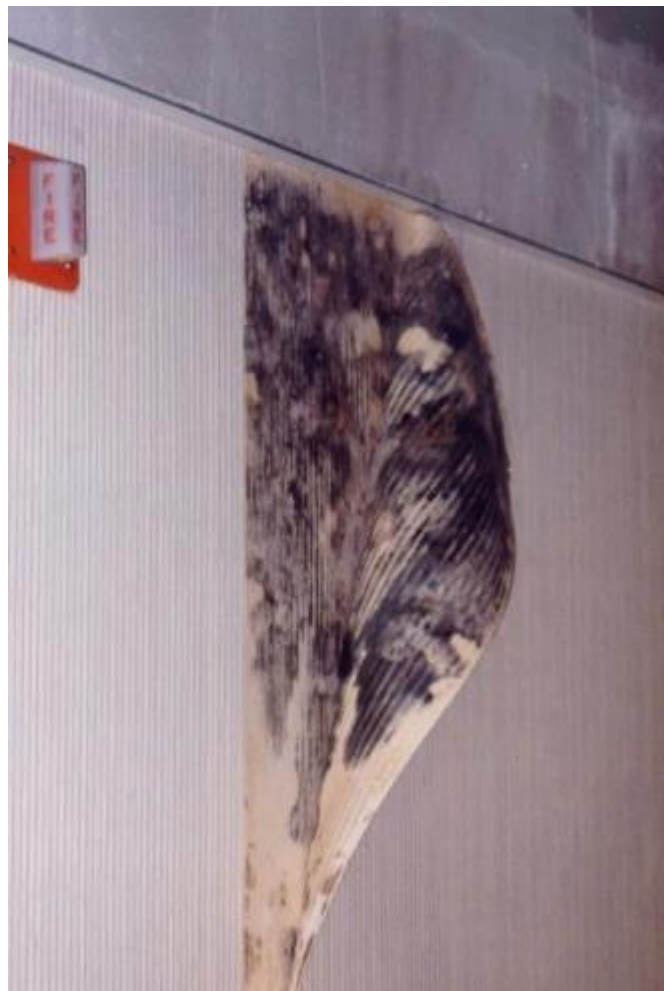
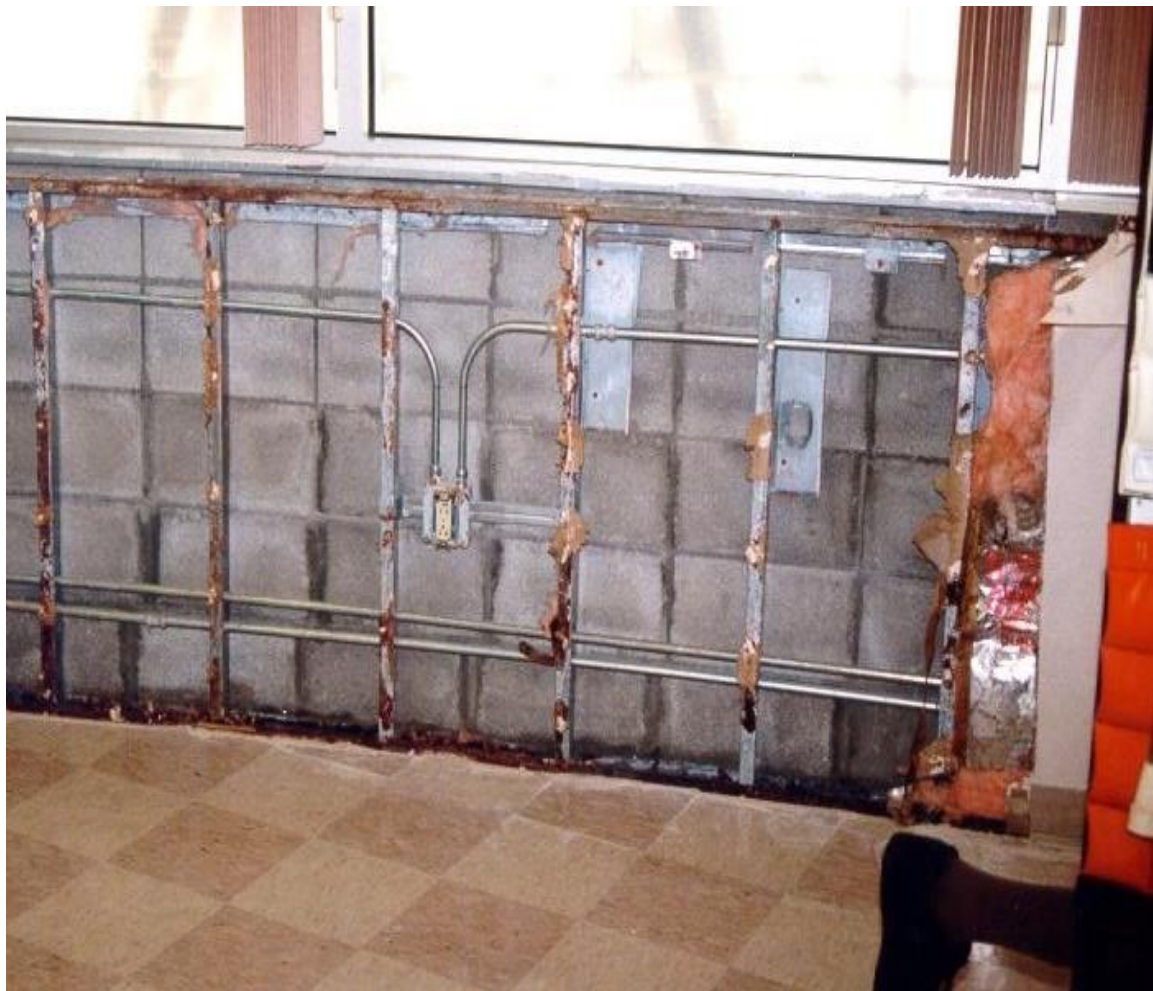
1. 4" brick veneer
2. 2" cavity with polystyrene insulation
3. 4" concrete masonry
4. 2" studs with foil-faced batt insulation
5. Gypsum wallboard
6. Vinyl wall covering

1. Water penetrates and saturates masonry during rains.
2. Air infiltration (due to negative pressure) carries moist cavity air into walls cooled by air conditioning
 - a. Damage is worse at areas with large negative pressure (infection control)
 - b. No damage at the positively pressurized ICU
3. The wall covering does not allow water to evaporate to the interior.
4. Mold grows on the paper face of the gypsum wallboard and paste for the wall covering.

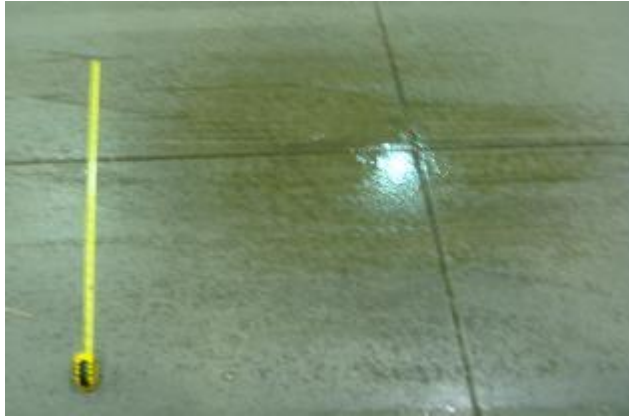
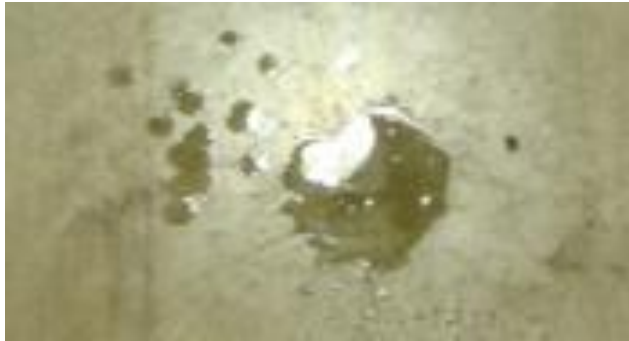
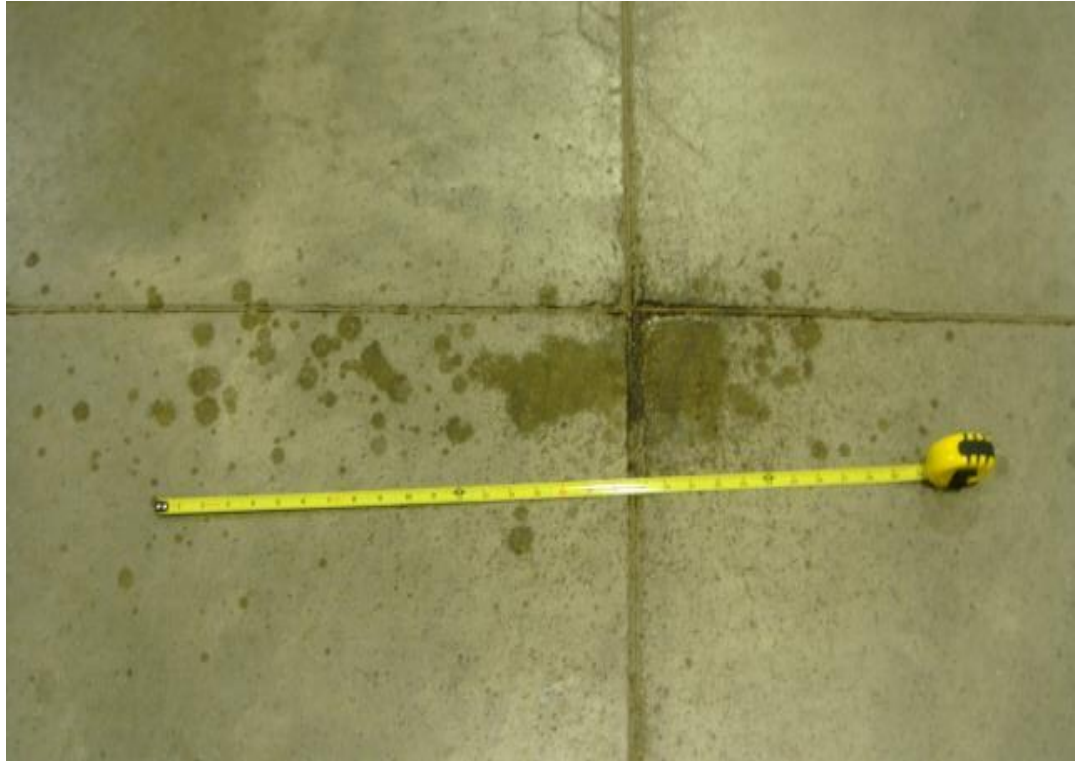
Water Dripping from Roof

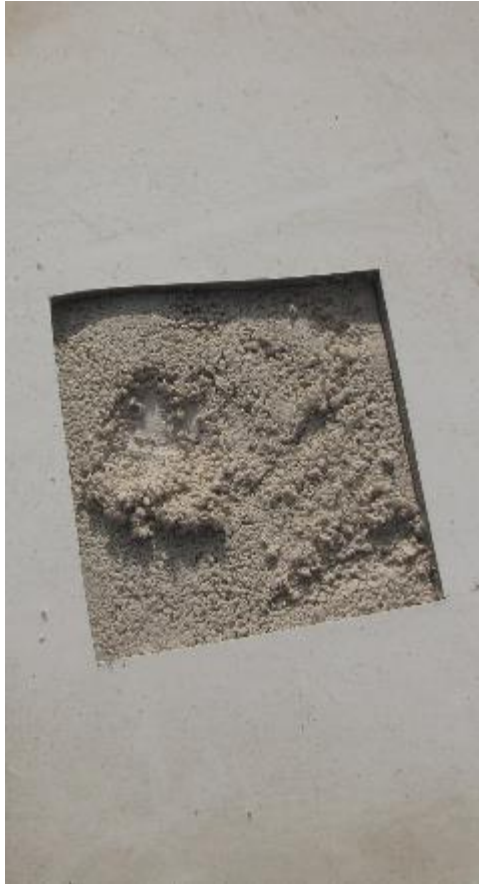
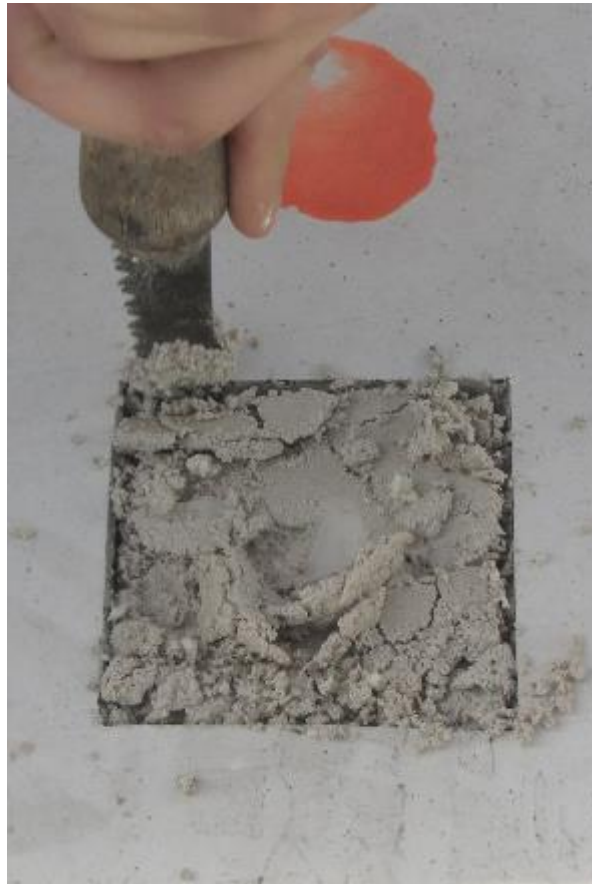
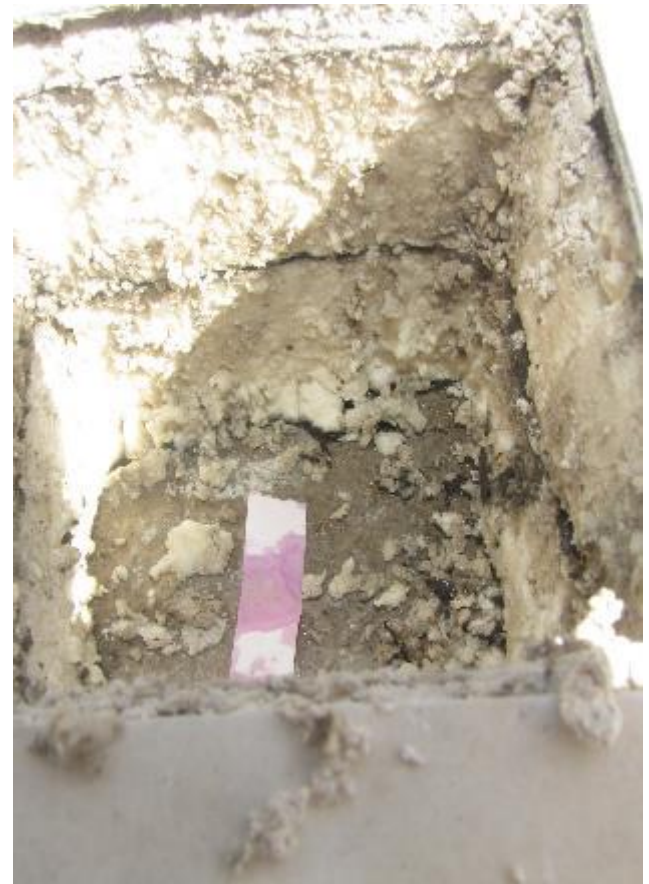
Moisture Damage in Roof

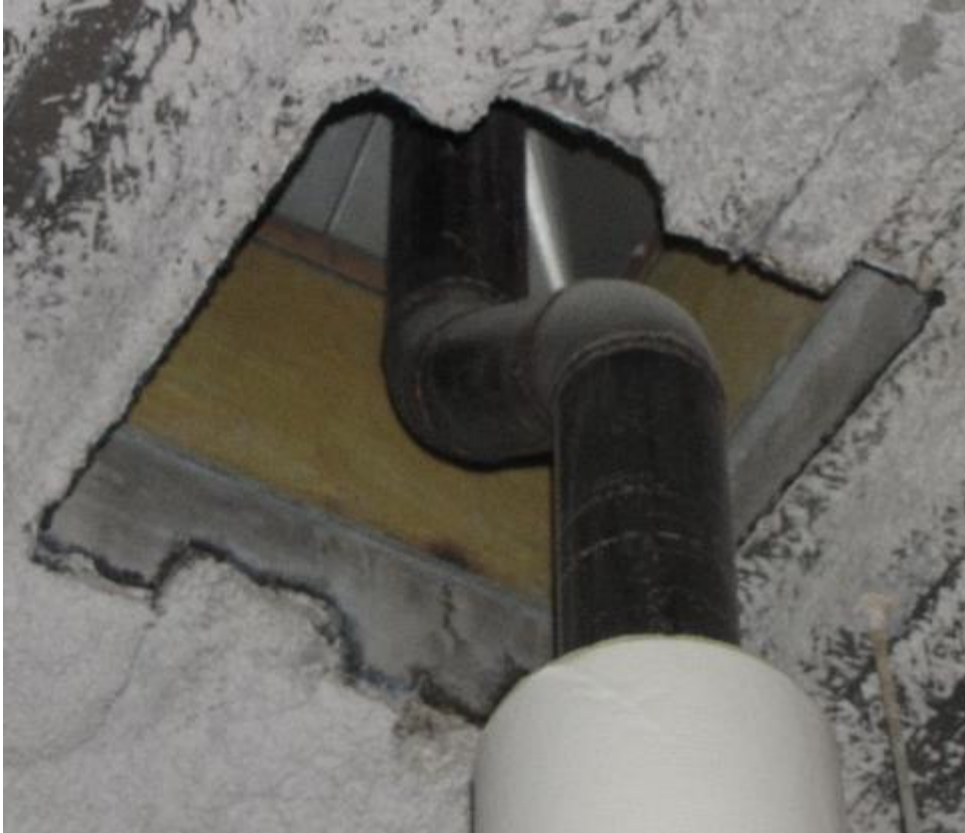
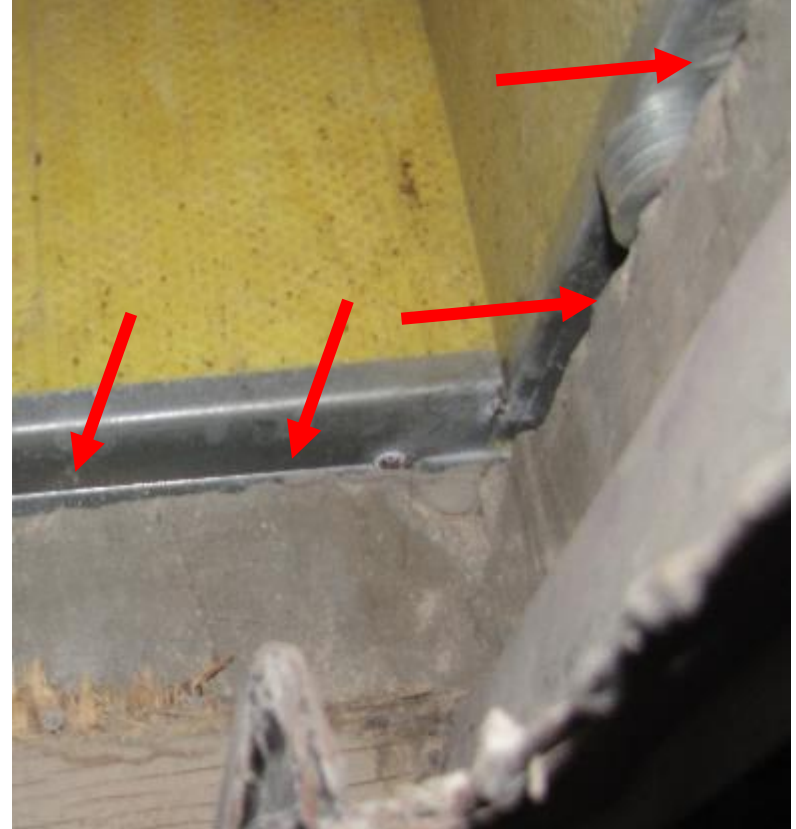
Cause (Airflow Path)

1. Install ballast to resist wind uplift and seal all roof deck penetrations with fire and smoke barrier as initial solution.
2. When roof is replaced in the future, install new air barrier on top surface of concrete that is fully sealed at all penetrations.
